United States  
Circuit Court of Appeals  
For the Ninth Circuit.

UNITED STATES OF AMERICA,  
Appellant,

J. LESLIE MORRIS COMPANY, INC., a cor-  
poration,  
Appellee.

Transcript of Record  
(Plaintiff's Exhibits 1 to 32)

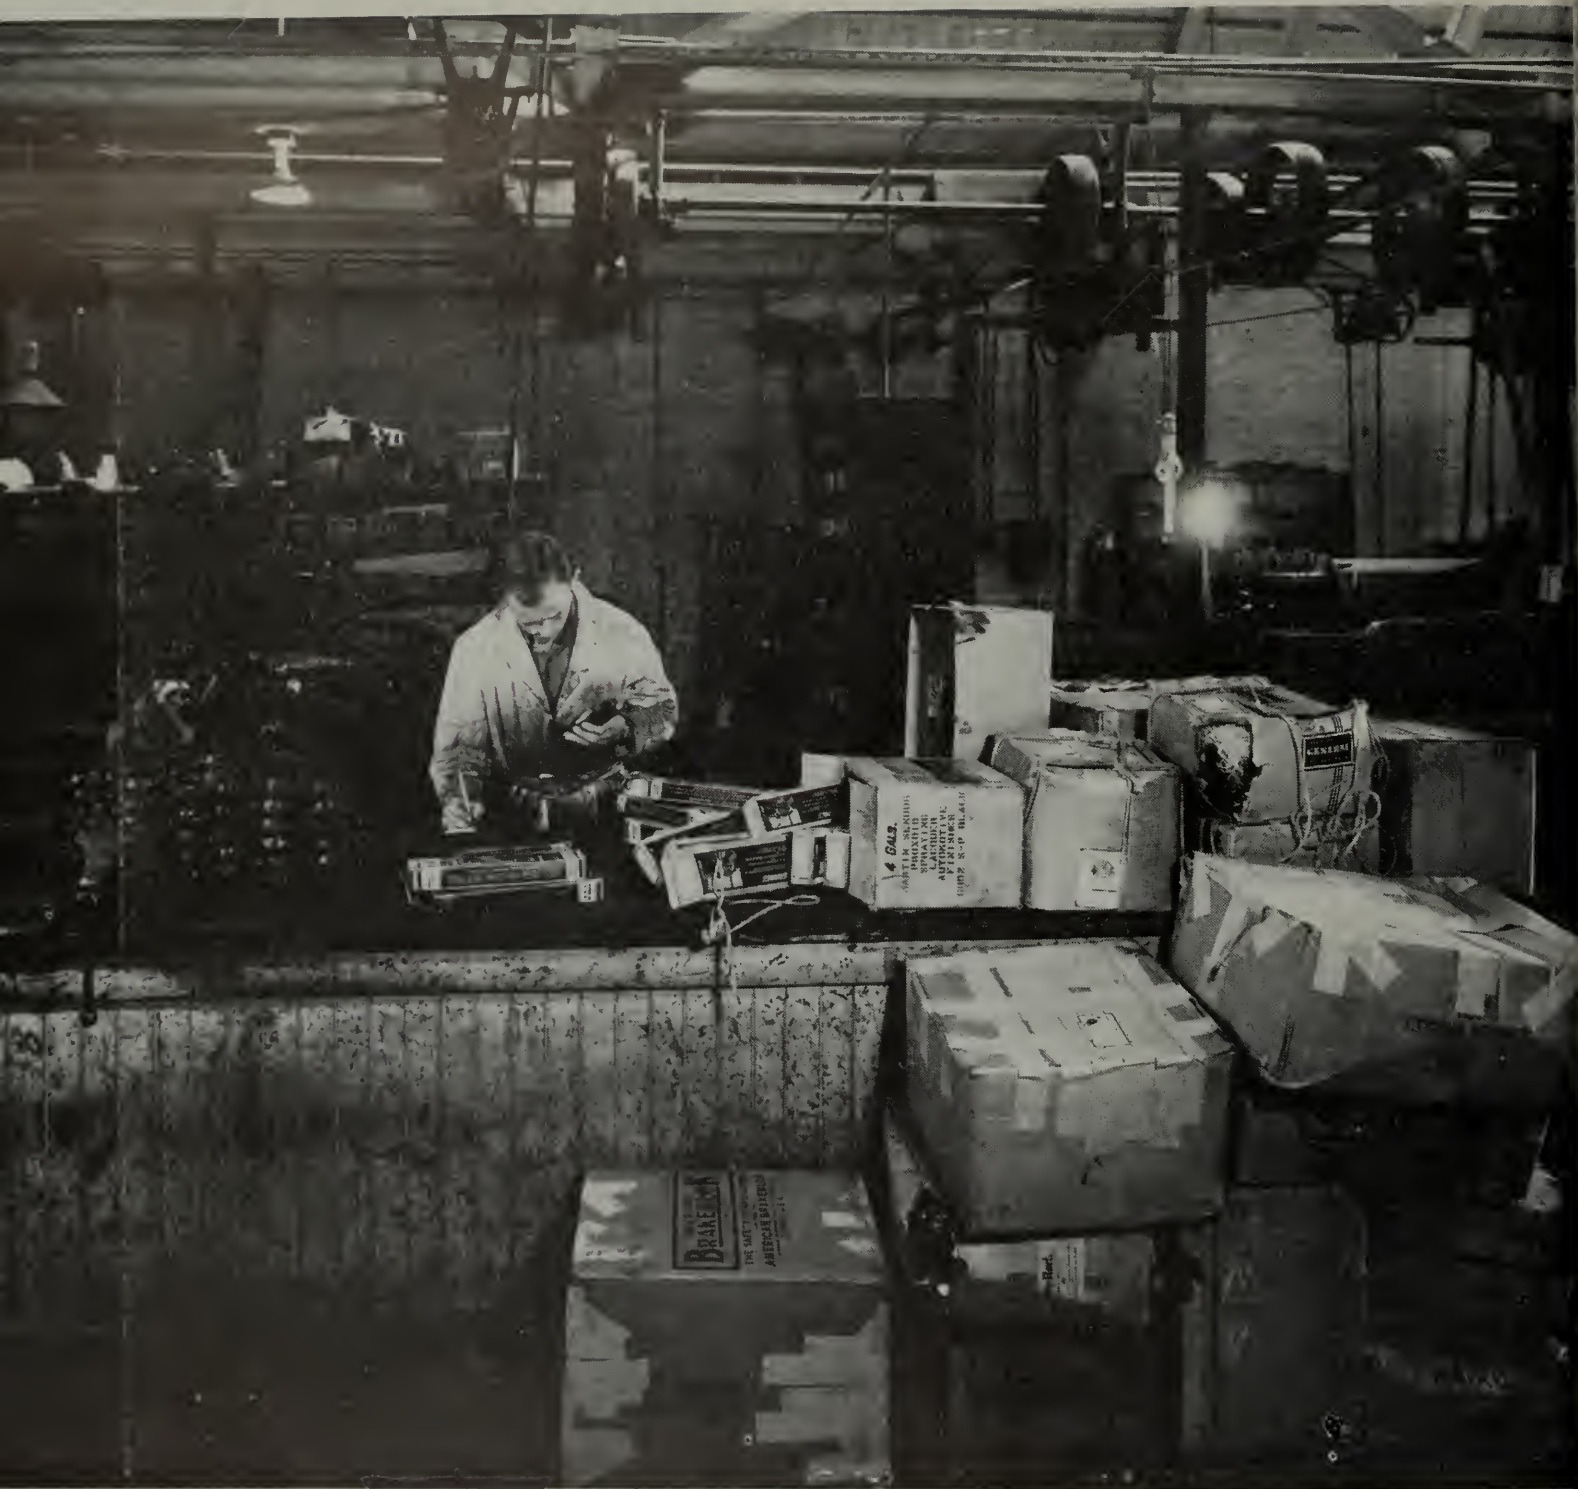
## PLAINTIFF'S EXHIBIT No. 1

Packages containing the rods for rebabbiting are received each day. They are shipped to Plaintiff corporation from three principal sources: automotive supply merchants frequently called "jobbers" (for example, Western Auto Supply Company, Chanslor and Lyon Stores, Collyear Motor Sales Company, et cetera) representing about 85 per cent of the rods received by Plaintiff corporation; commercial accounts (for example, Barker Brothers, Greyhound Stages, Baker Ice Machine Company, et cetera) representing approximately 10 per cent of the rods received by Plaintiff corporation, and automobile dealers (for example, Paul G. Hoffman Company, Howard Auto Company, Greer Robbins Company, et cetera) representing about 5 per cent of the rods received by Plaintiff corporation. When the various packages of rods are received they are piled at or near the doorway of Plaintiff corporation as shown (above). Each shipper does not make his shipments daily but are only sent to Plaintiff corporation when sufficient accumulation warrants their shipment. They are received in packages varying from one to one hundred rods per package, however, averaging from twenty to sixty rods per package. They are brought in by either shippers own delivery service, by parcel post, or by various light trucking companies, or delivery services. About ..... per cent of the rods sent in by automotive supply merchants i. e. "jobbers" are shipped to Plaintiff in Plaintiff corporation's boxes from which the rods rebabbiting by plaintiff corporation have been sold. That is, the "jobber" in selling one of Plaintiff corporation's rods to a garage man or other purchaser removes from the box the rod delivered to him by Plaintiff corporation and takes the rod which the garage man has brought in for exchange and places it into the box from which Plaintiff corporation's rod was removed. This is only done for the purpose of enabling the "jobber" to keep the various sizes of rods segregated, otherwise in order to make up his invoice list for shipment to Plaintiff corporation it is usually necessary for the shipper to place an identification tag on the rod.

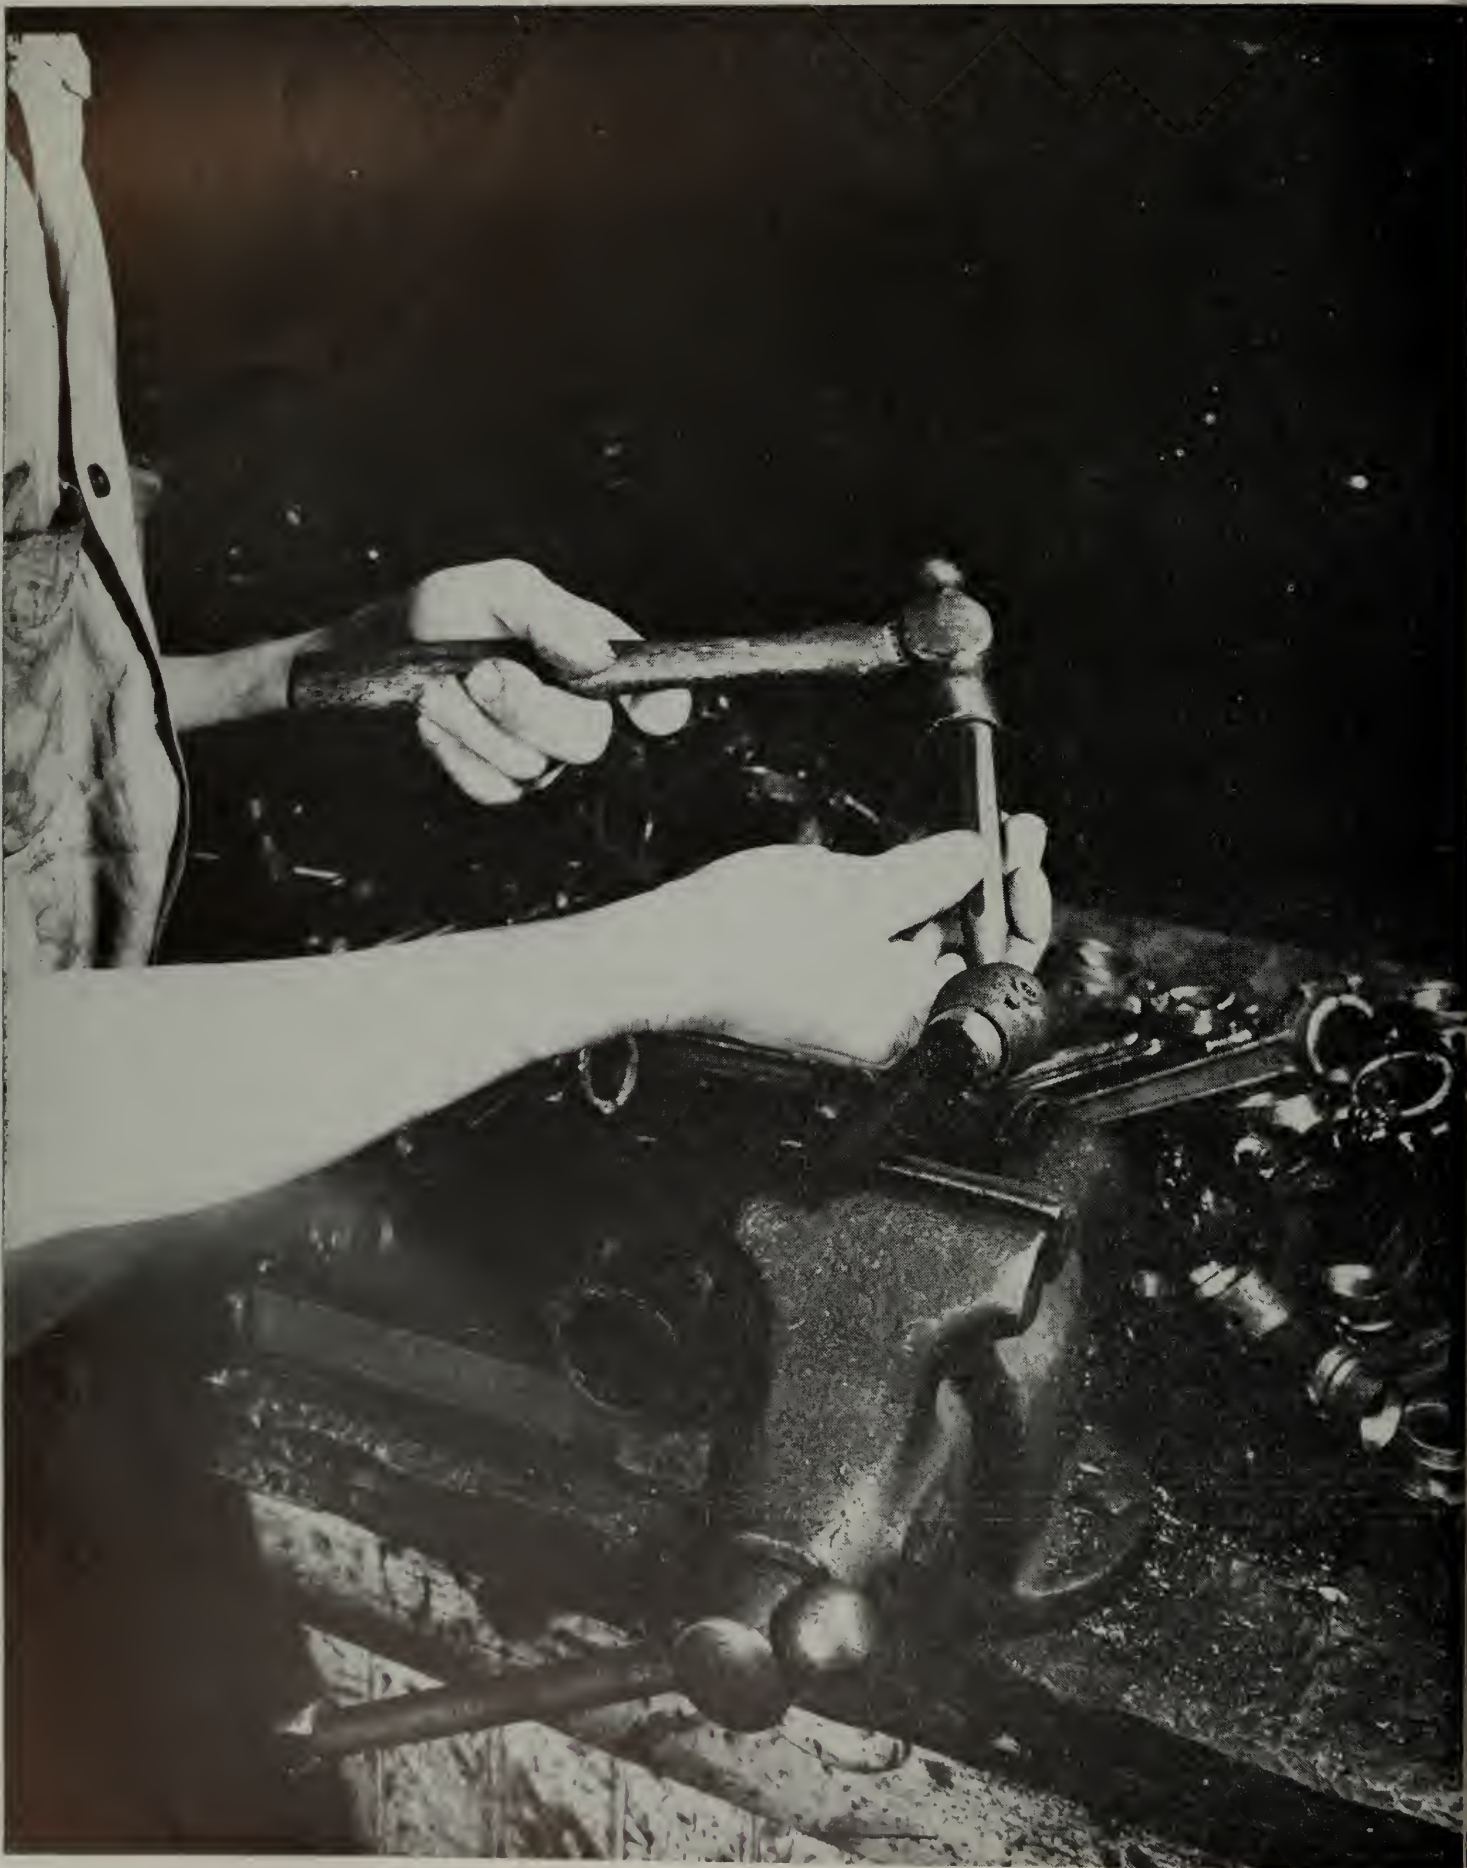
PLAINTIFF'S EXHIBIT No. 2

After the packages of rods are left at or near the door they are removed inside. Then each package is opened and the rods enclosed are checked against the shippers invoice and the invoice corrected if necessary (as shown above). Plaintiff corporation reserves the right to correct all invoices in accordance with the actual shipments of rods by customers. Any instructions for re-babbitting are removed from the package. About 10 per cent of the rods received call for a special specification or order for re-babbitting. This special specification or order is occasioned by the crankshaft having been worn or ground smaller so that the cap end of the rod must itself be smaller. As previously indicated many of the rods are shipped in Plaintiff corporation's boxes. If they are shipped loose the identification tags are removed from the rods. Then the boxes and tags removed from the packages are discarded.

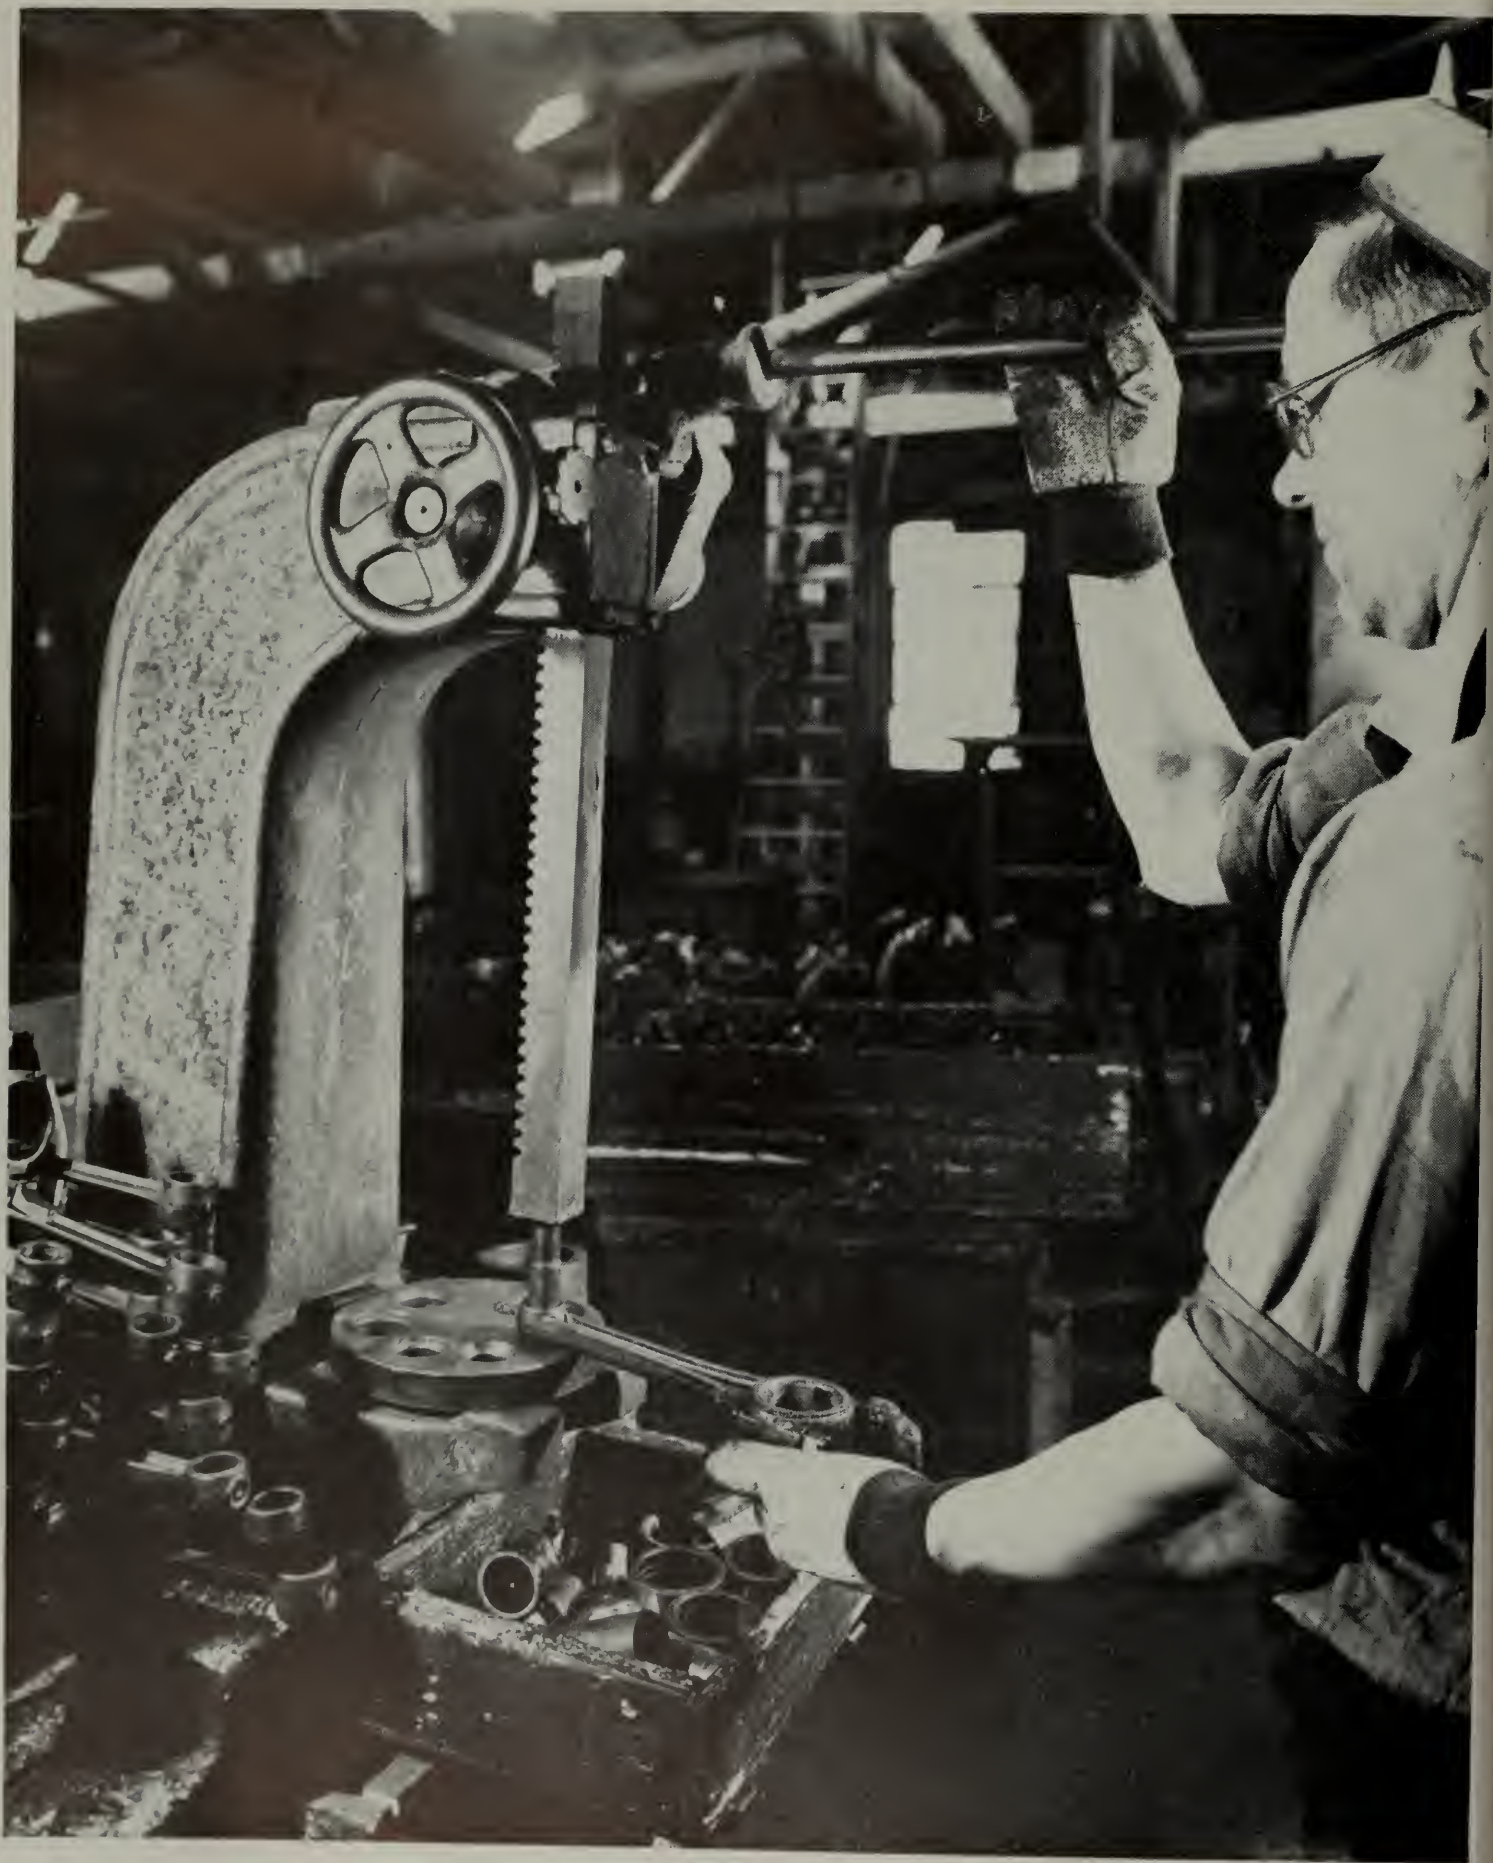
PLAINTIFF'S EXHIBIT No. 3

The rods are then piled on a table in groups according to their respective sizes and the pin bushings are removed. These pin bushings are the bushings at the shank end of the rod. About one half of the rods rebattitted by Plaintiff corporation use pin bushings. The other half are of a clamp type shank end and using no such pin bushings this operation of removal is not necessary. And sometimes the instructions received read "Do not change bushings." These pin bushings are of two types: Those with a thin wall which cannot be pressed out and which must be therefore pounded out by means of a cold chisel and hammer as shown above while

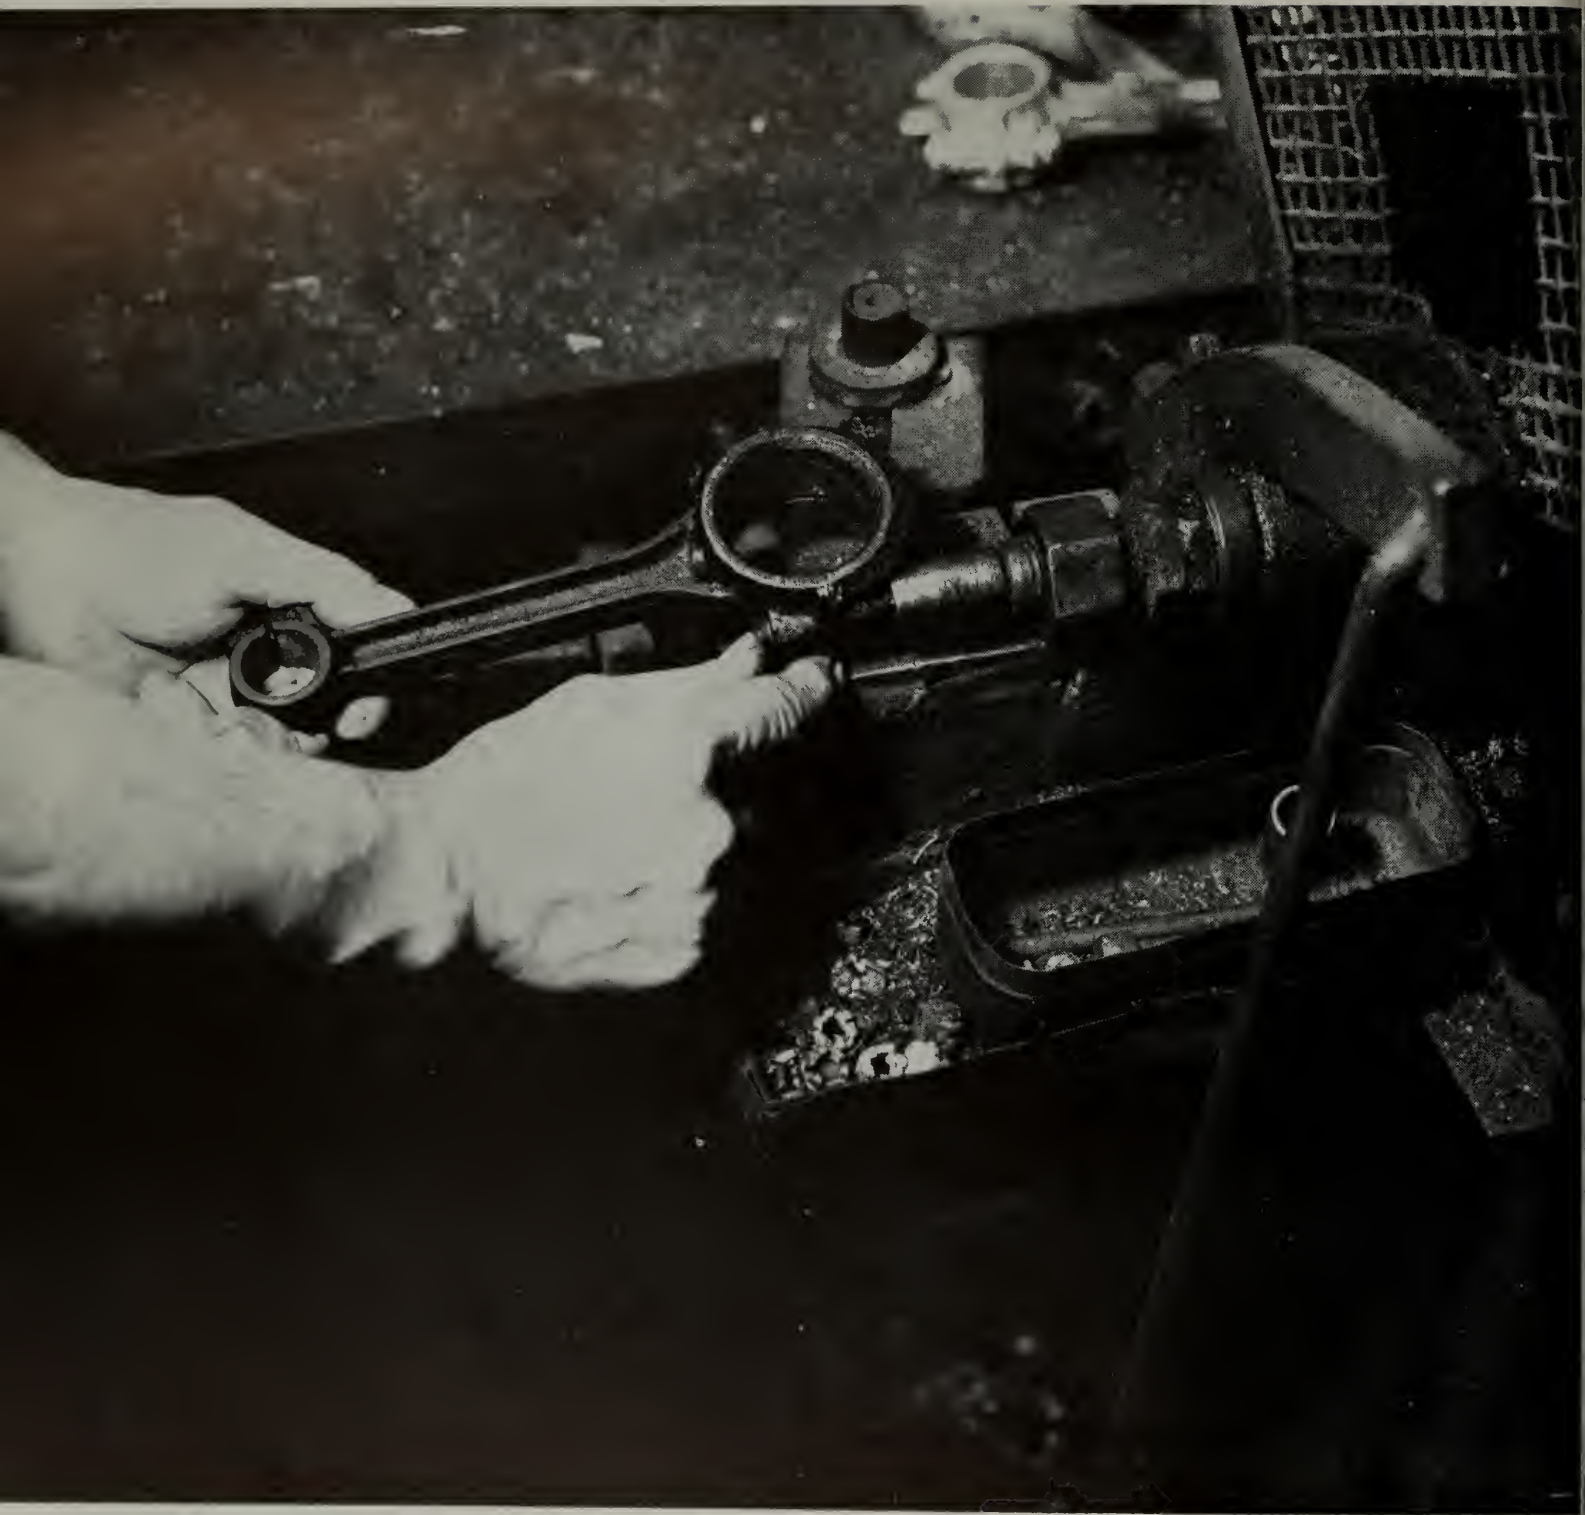
PLAINTIFF'S EXHIBIT No. 4

Other pin bushings have a heavy wall and are removed by use of an ordinary arbor press as shown above. It is much simpler and faster to remove the bushings in this manner.

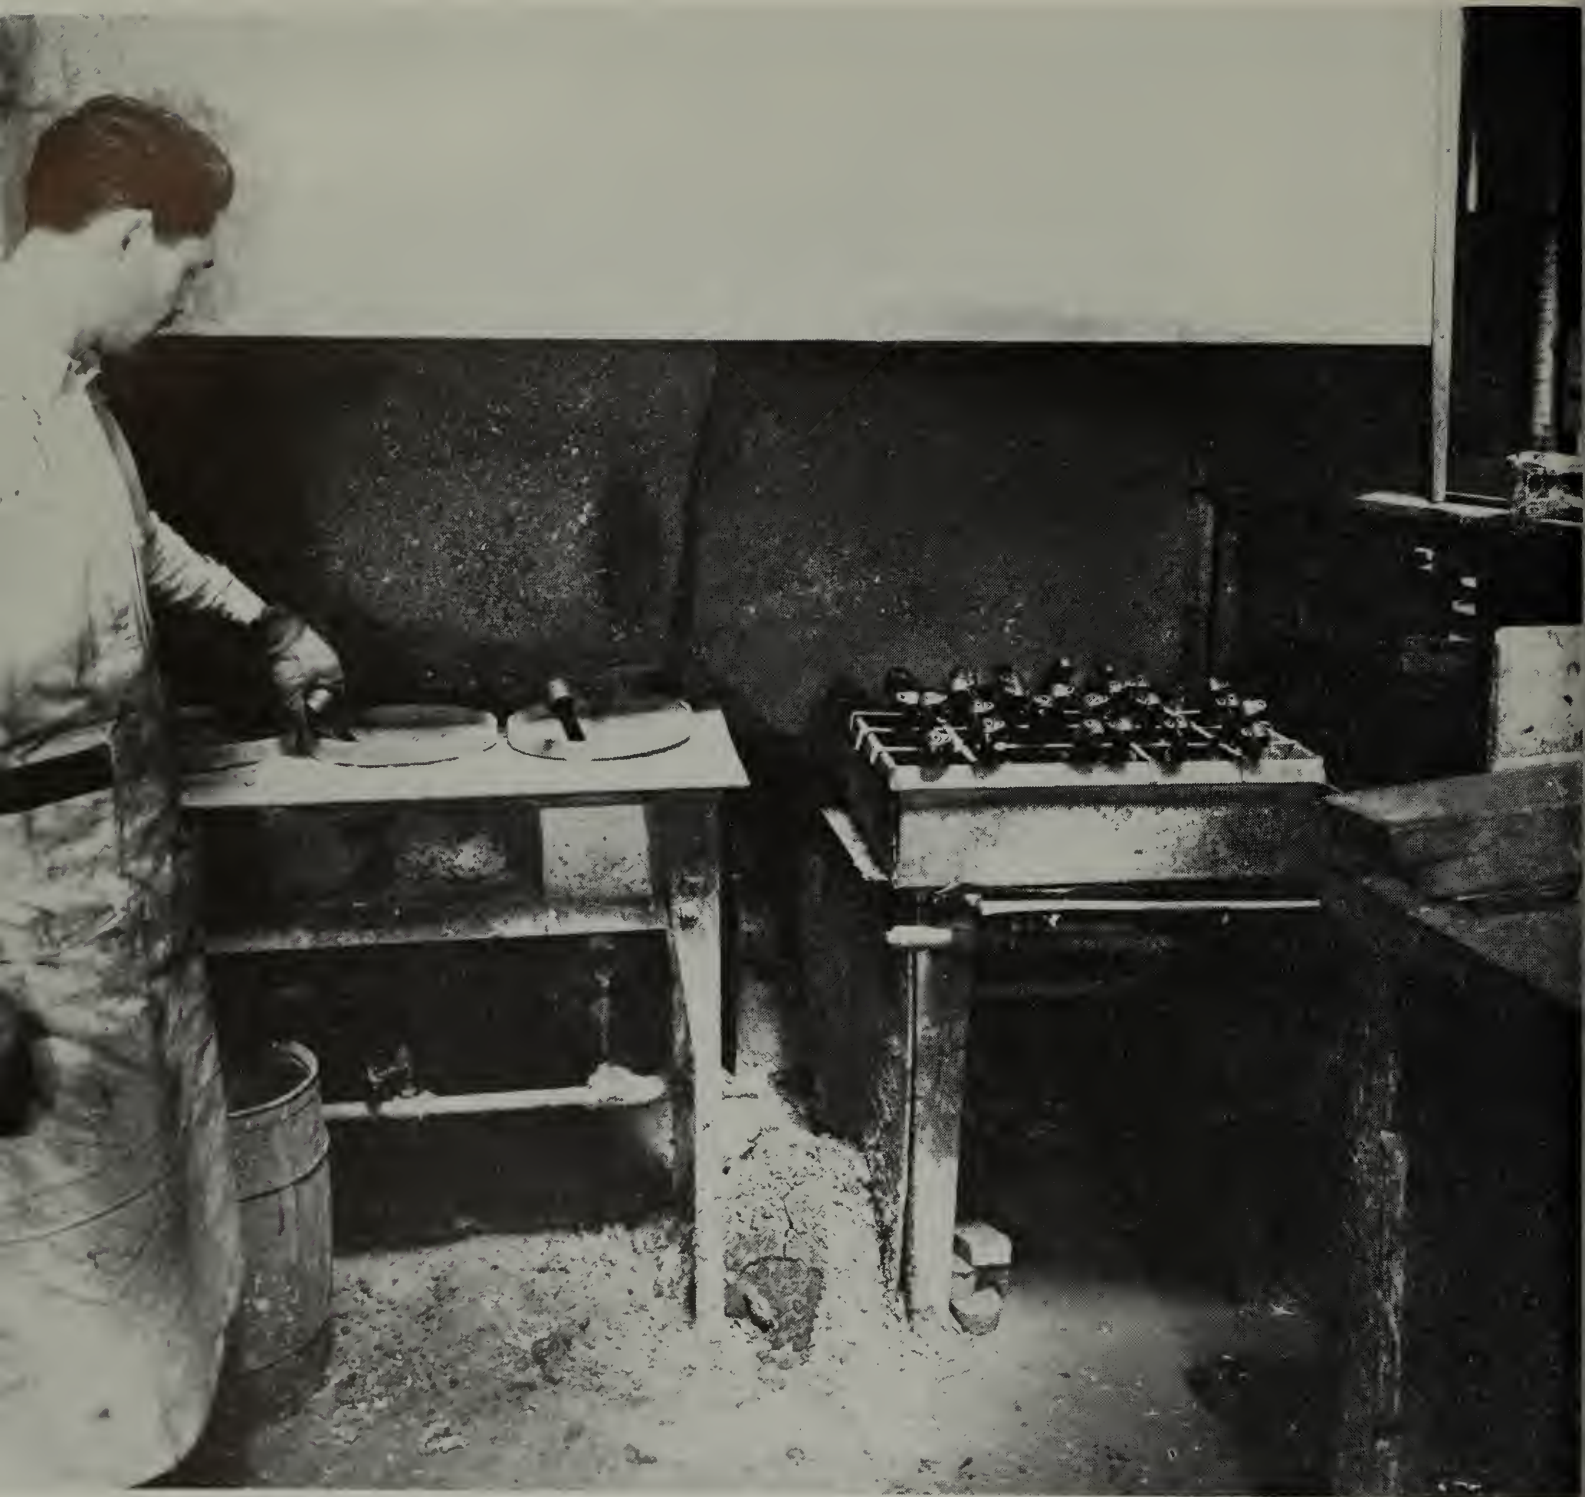
## PLAINTIFF'S EXHIBIT No. 5

On about one half of the rods it is necessary to remove the bolts and nuts which fasten the cap to the shank and replace these bolts and nuts with auxiliary bolts and nuts which have already been dipped in solder. The nuts and bolts so removed are placed in a box and later replaced on the rods in place of the auxiliary nuts and bolts when the rebabbiting process is completed. The same cap always goes back on the same shank otherwise in the centrifugal casting the babbitt will leak. However, on Ford products the bolts are not removed for the reason that no bolts are made, but rather, a stud has been forged with the shank and cannot be removed. However, the nuts are similarly changed and for the same reason as in the case of the other rods. The reason for this operation is that on about one half of the types of rods the nuts and bolts have never been immersed in solder, and it is desired to rebabbit the rod so that its appearance resembles that of its original condition as nearly as possible. On the other one half of the rods, that is on the rods on which the nuts and bolts have previously to the time received by Plaintiff corporation been immersed in solder, there is no necessity for this operation, and the nuts and bolts are merely tightened if they are loose. The tightening of the nuts and bolts is accomplished by means of an ordinary hand socket wrench attached to a slowly revolving power driven spindle operated by means of a foot lever as shown above. The opposite end of this spindle revolves in the opposite direction and is used in loosening and removing the nuts and bolts, by the same type socket.

Then the steel separator shims are removed by the means of the socket wrench shown in picture number five, and any auxiliary nuts and bolts are removed and the originals replaced.

The cap is replaced on the rod using the original bolts and nuts, the removal of which was described in Picture 5. A power driven socket wrench is used in performing this operation.

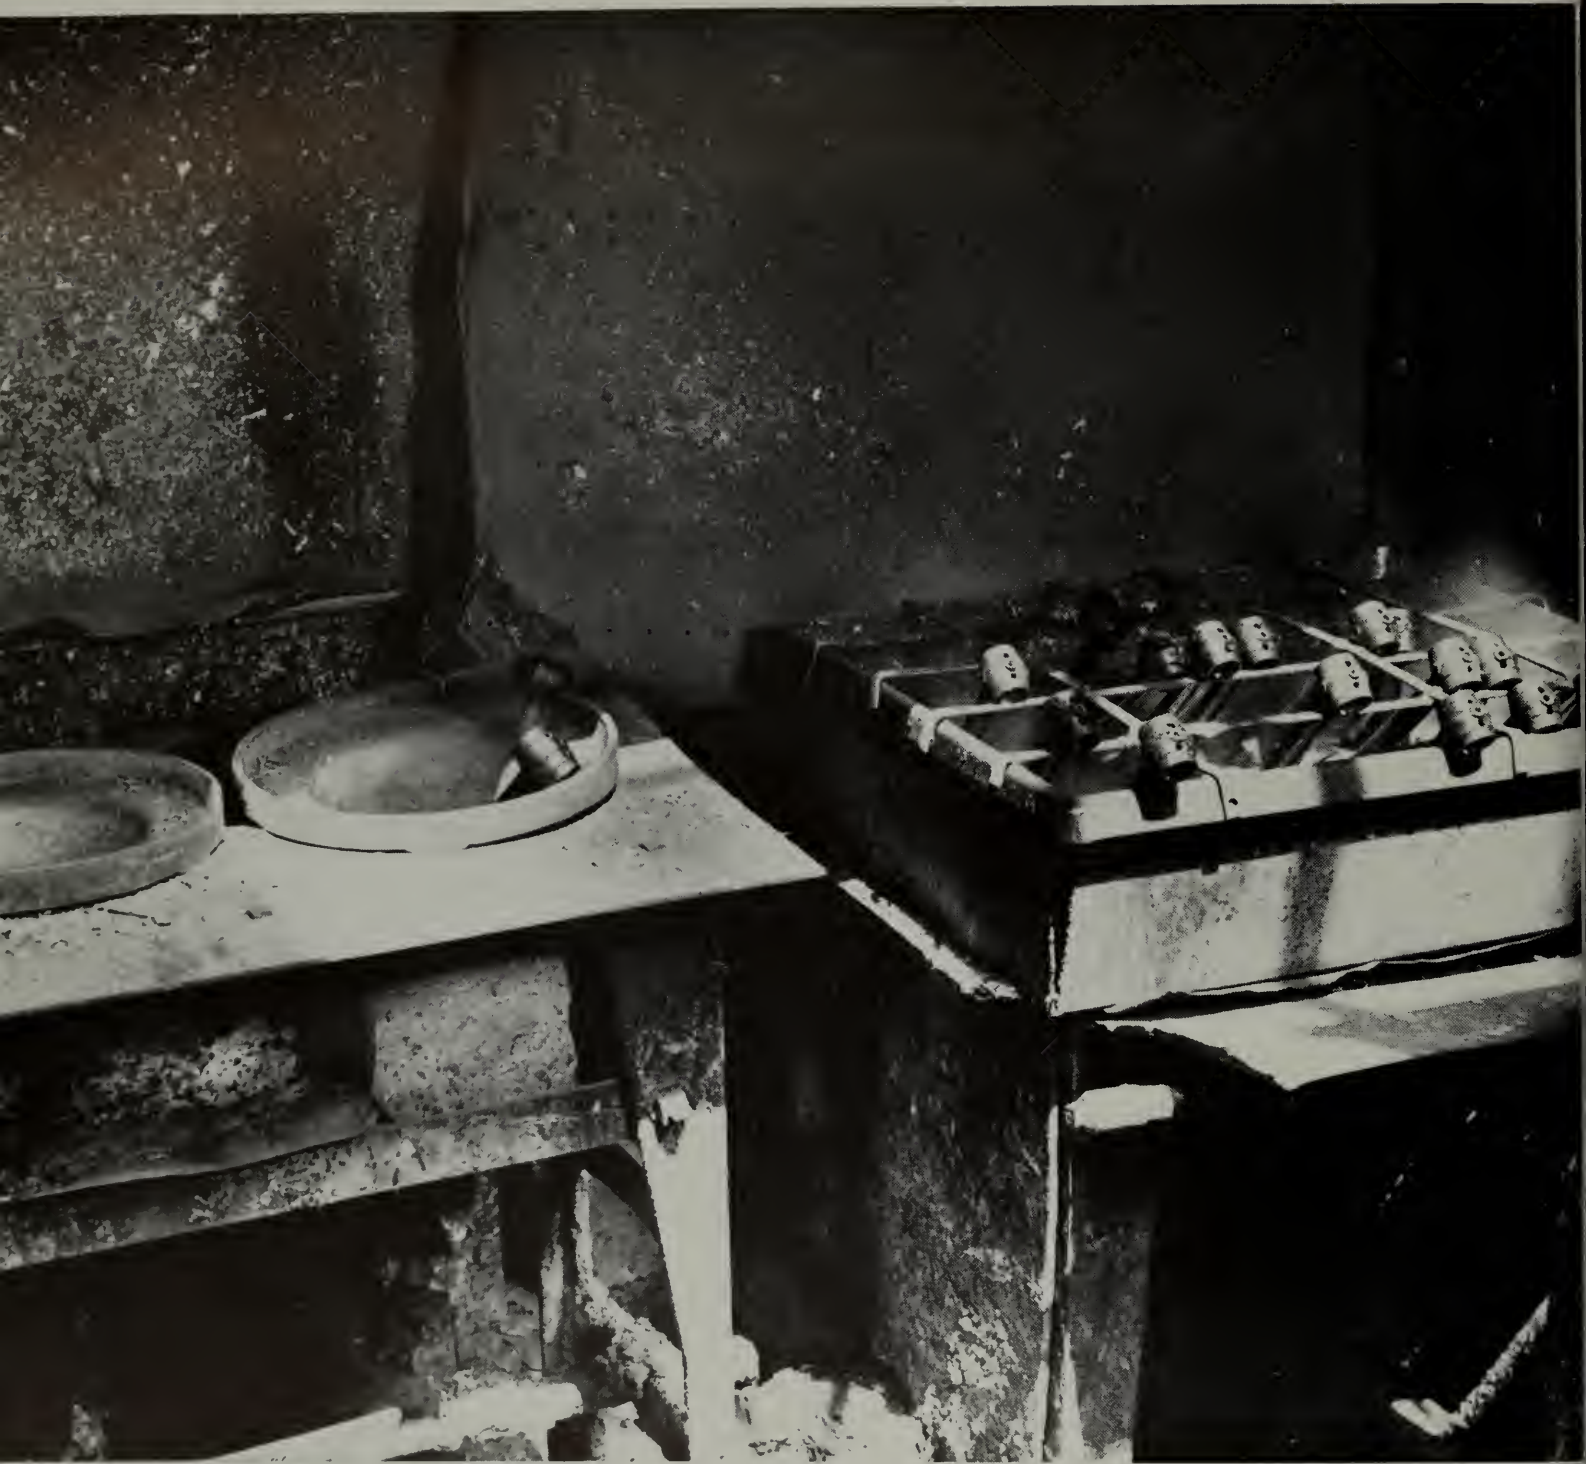
PLAINTIFF'S EXHIBIT No. 6

Then the babbitt is melted from the bearing end of the rod by placing that end into a low temperature pot of molten babbitt which the night man prepares by lighting the oven at approximately five o'clock in the morning in preparation for the days run. It is heated with an ordinary gas stove burner. This operation is illustrated in the right half of the above picture. After most of the babbitt is removed by this method, the remainder of the adhering babbitt or dross which sometimes clings to the rods is removed by dipping them into the dross pots shown to the left in the above picture. The dross pots keep a solution of molten babbitt at a higher temperature. In order to keep the babbitt at a sufficiently high temperature three approximately one half gallon pots are used. The reason for the babbitt being removed by two operations is that the babbitt in the low temperature receptacle may be used by Plaintiff corporation for rebabbitting, while the higher temperatures in the dross pots spoil the babbitt for such use.

Close-up of operation illustrated in picture 6.

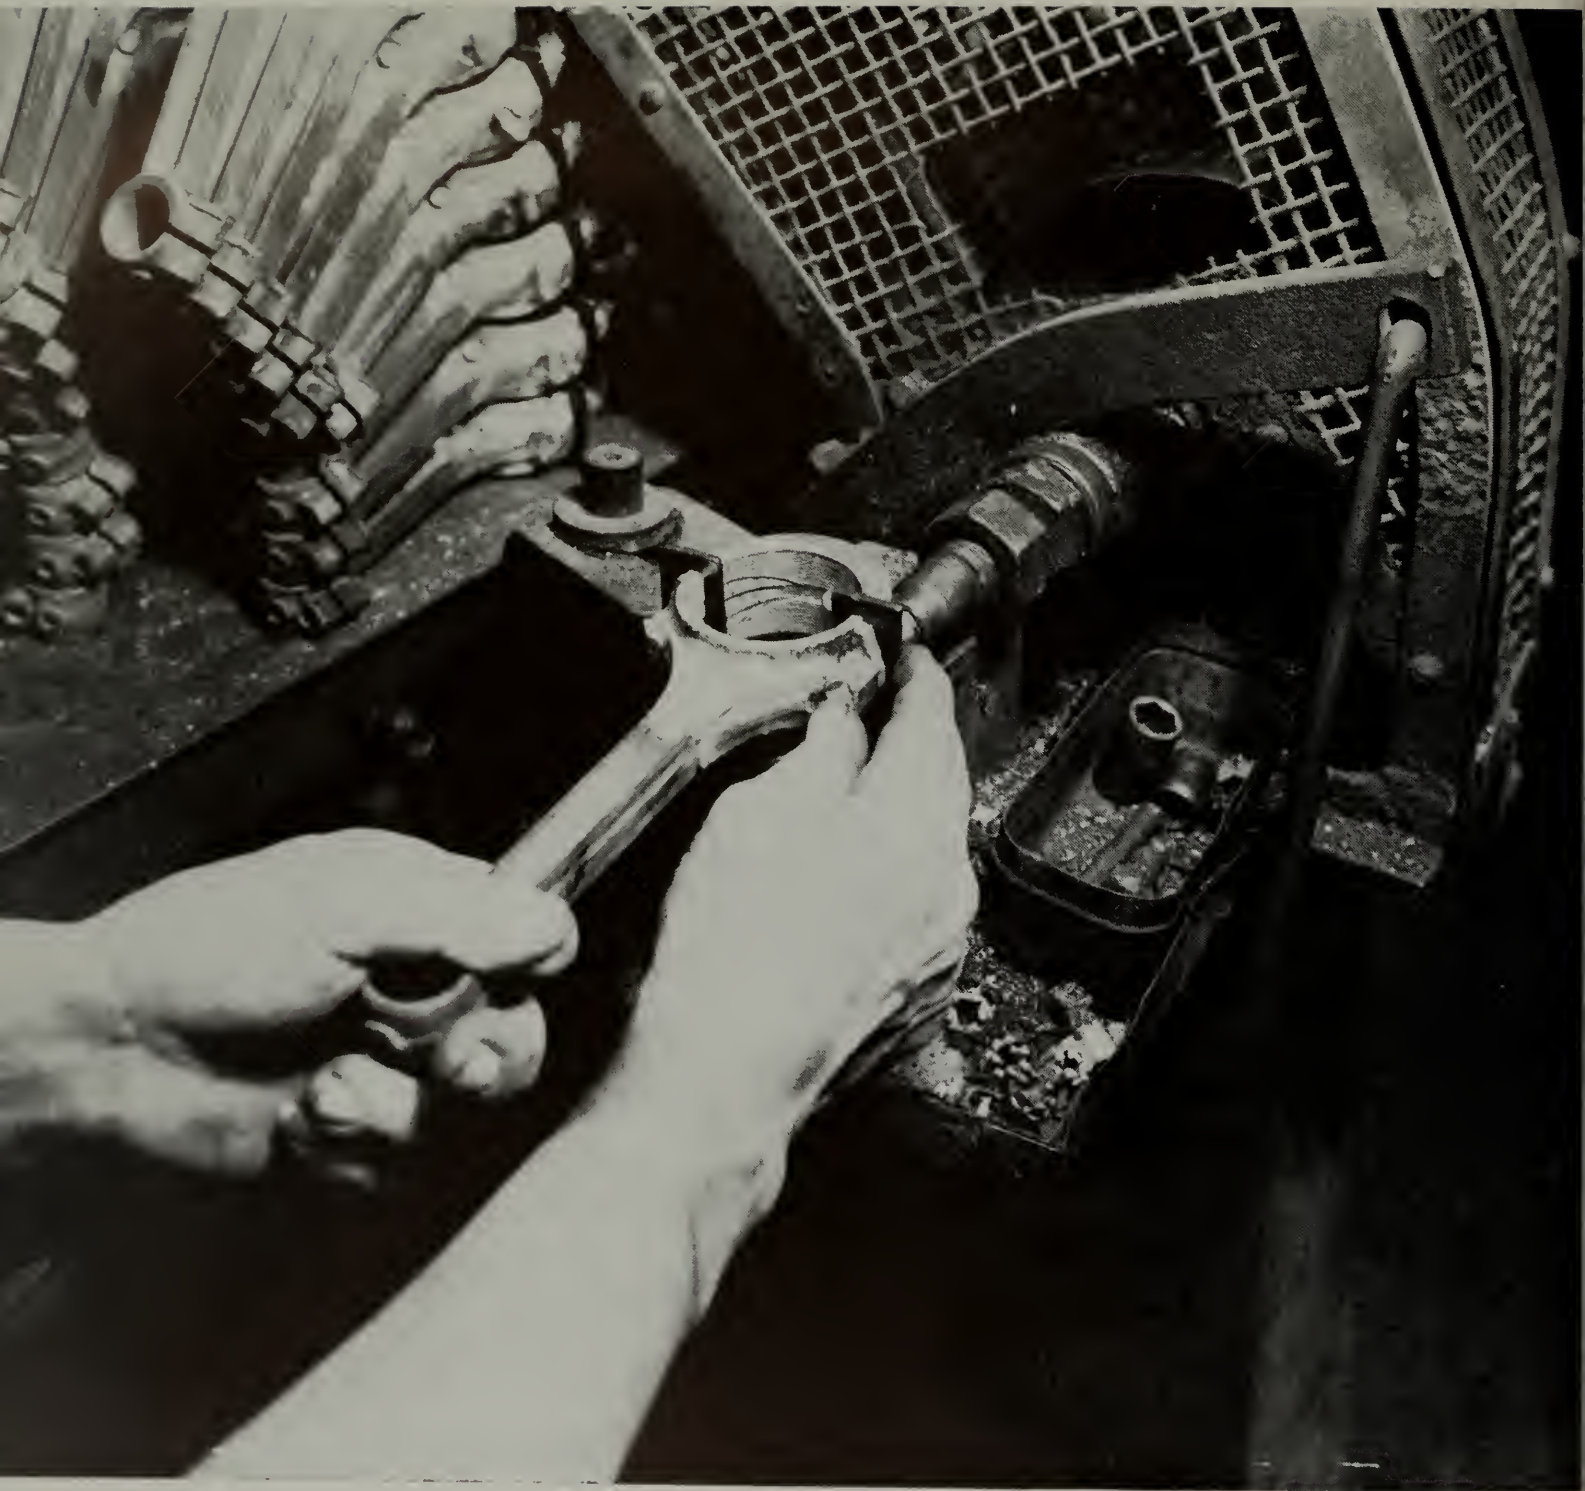
PLAINTIFF'S EXHIBIT No. 8

After any remaining babbitt is chipped off with a chisel, the bearing end of the rod is then dipped into a solution of hydrochloric acid. The acid acts as a cleaning agent. The acid vat is under the wooden cover shown at the right in the above picture. Then the bearing end of the rod is dipped into a molten tin or solder shown on the left in the above picture. This solder or tin acts as a flux or bond when the babbitt is cast against it.

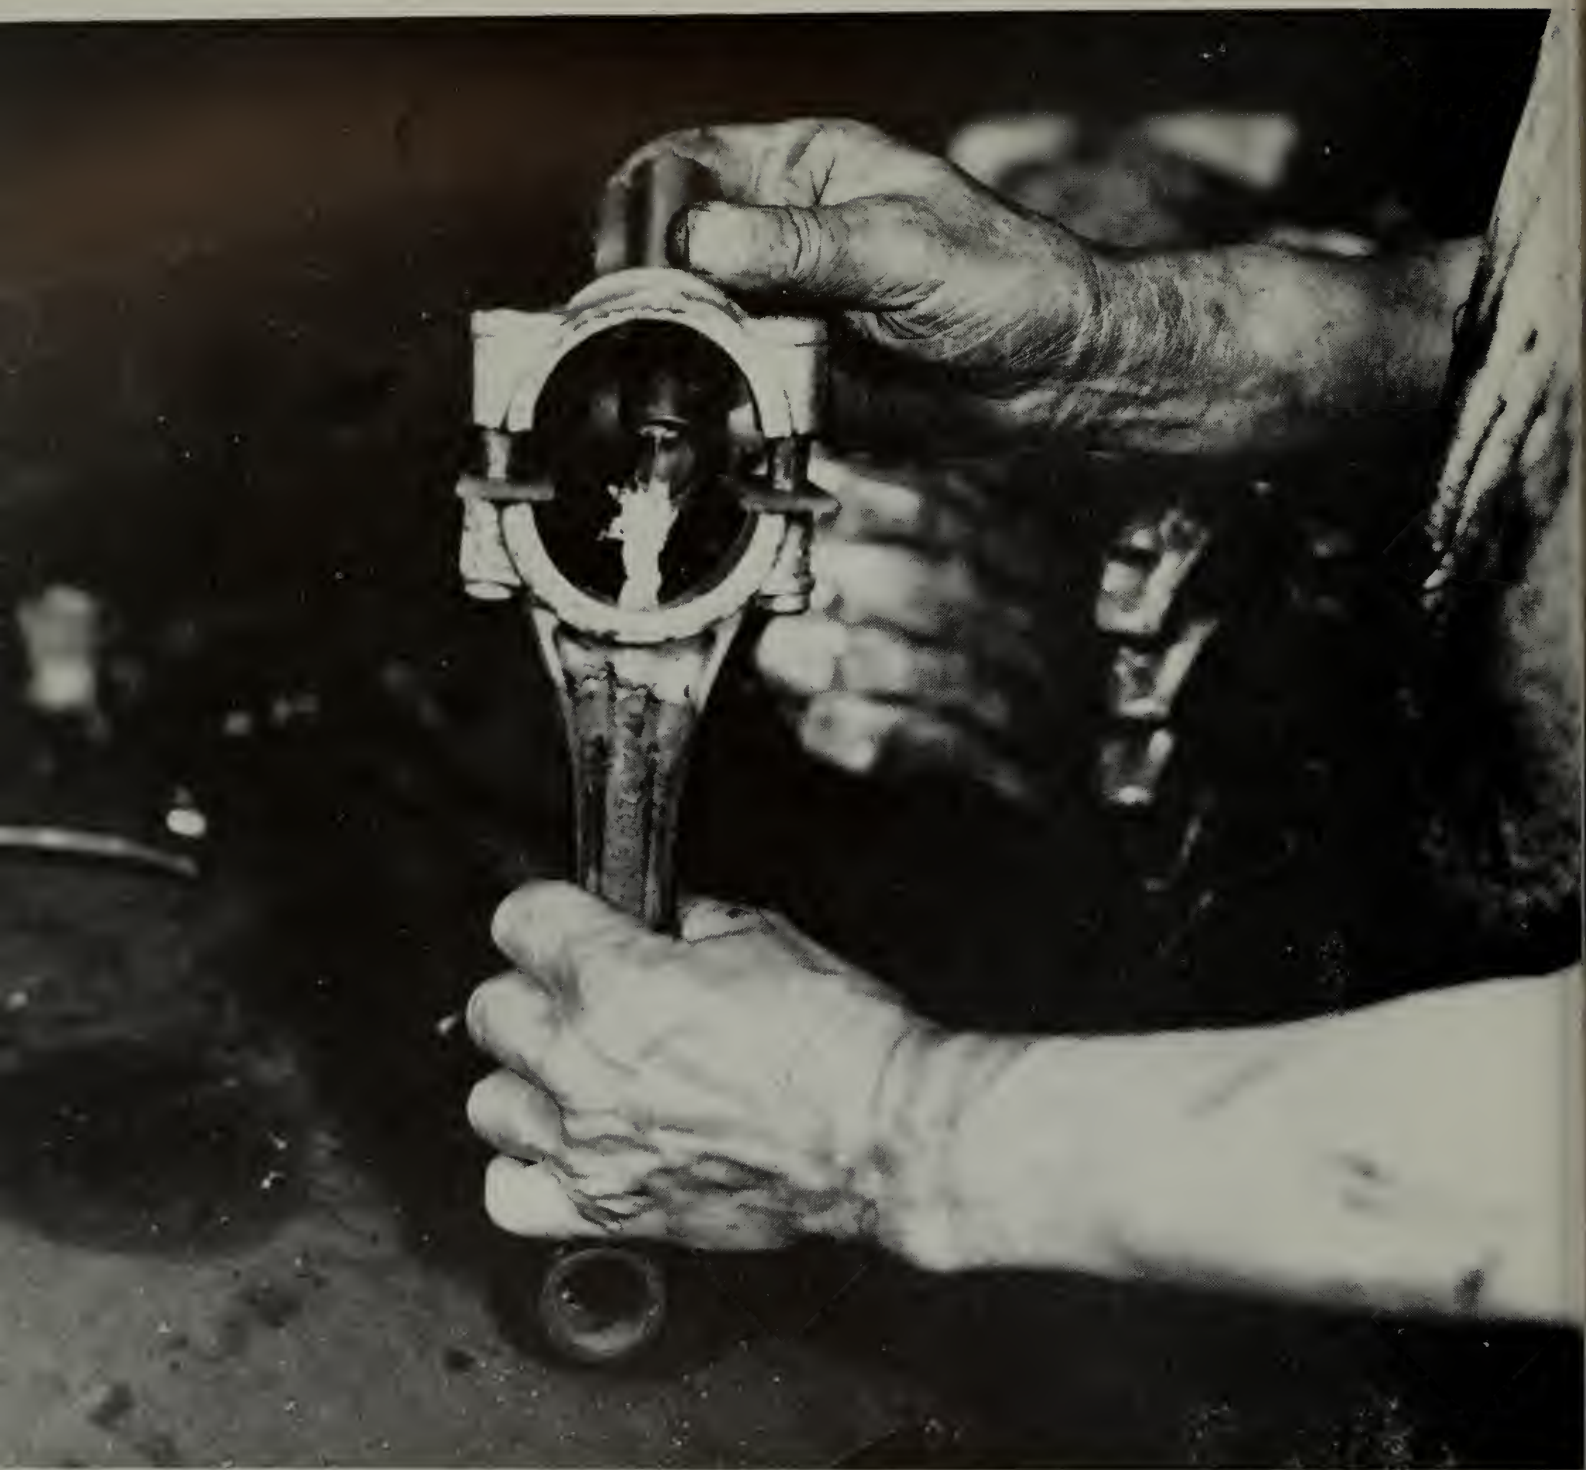
PLAINTIFF'S EXHIBIT No. 9

Then the nuts are removed from the bolts holding the cap to the bearing end of the rod and by means of a sharp blow the cap is removed from the bearing end of the rod, and a steel separator is inserted between the cap and the bearing end of the rod on each side where the cap joins the rod as shown above. These separators prevent the rod and cap from casting together when the babbitt is rebabbitted. The same power driven socket wrench described in picture number 5 is used for the removing of the nuts and for the replacing of the nuts when the separators have been inserted. Separators are not used in rebabbiting rods for Model A Ford engines for the reason the cap is cast to the bearing end of the rod.
